# Manhole Inspection Summary

Manhole # S39E\_\_011MH

Insp Date: **11/6/08 1:59 PM**

**Location** Address: **805 e fayette st**

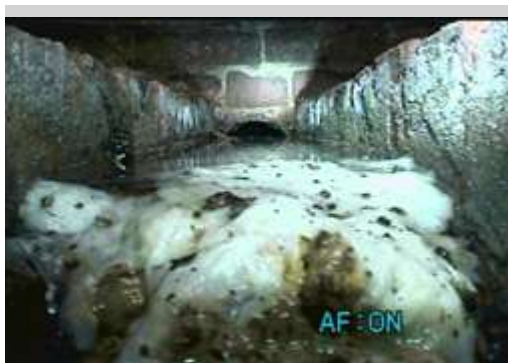
Defect 2

Condition: ☐ Sound ☐ Cracked ☐ Root Intrusion ☐ Deteriorated ☐ Leaks ☒ **Debris**

channel debris

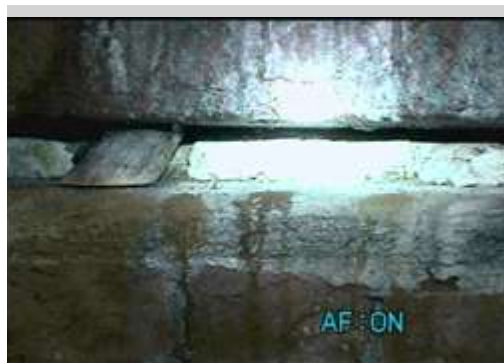
Defect 1

Condition: ☐ Sound ☐ Cracked ☐ Root Intrusion ☐ Loose Brick ☒ **Deteriorated**

deteriorated

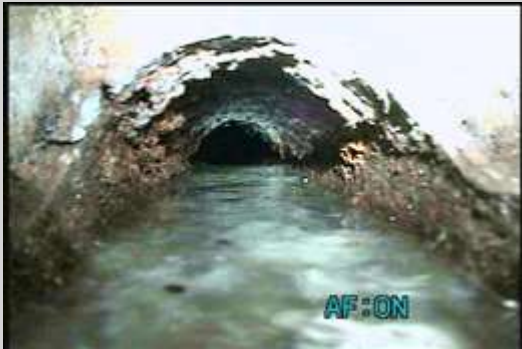
12 O'Clock Outflow

4 in. Circular Gravity Sewer  
Pipe Out @ 12 O'Clock

Pipe Material: Clay ☐ Pipe Lined

Invert Depth: 3.88 (ft.) Flow Characteristics: Slow

Deposits: ☒ None ☐ Mud ☐ Sludge ☐ Debris ☐ Grease

Infiltration: None

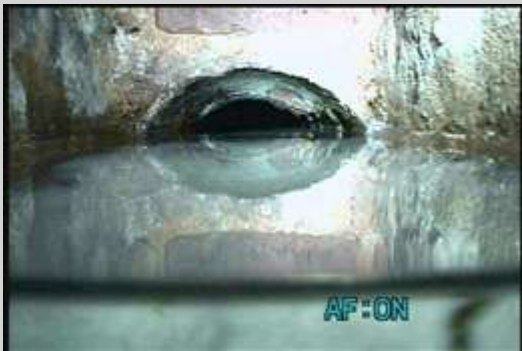
6 O'Clock Inflow

4 in. Circular Gravity Sewer  
Pipe In @ 6 O'Clock

Pipe Material: Clay ☐ Pipe Lined

Invert Depth: 3.83 (ft.) Flow Characteristics: Slow

Deposits: ☒ None ☐ Mud ☐ Sludge ☐ Debris ☐ Grease

Infiltration: None
